*Supplemental Update to
Protected Tree Removal Report
929 Border Avenue, Del Mar, CA
August 13, 2020
Update September 13, 2022*

Supplemental Arborist
Protected Tree Report Update
September 13, 2022

Protected Tree Removal Report
929 Border Avenue, Del Mar, CA

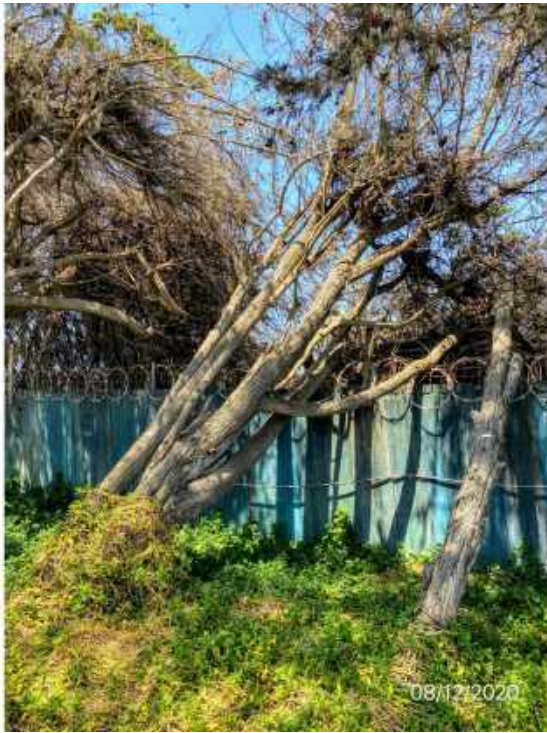
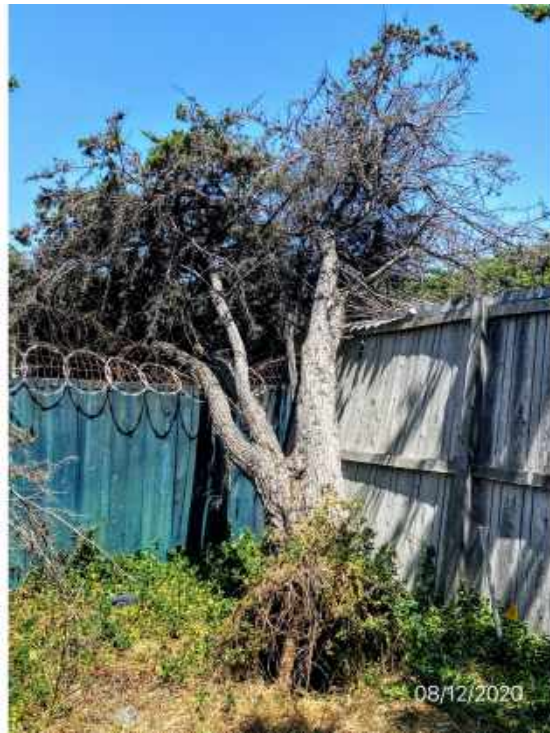
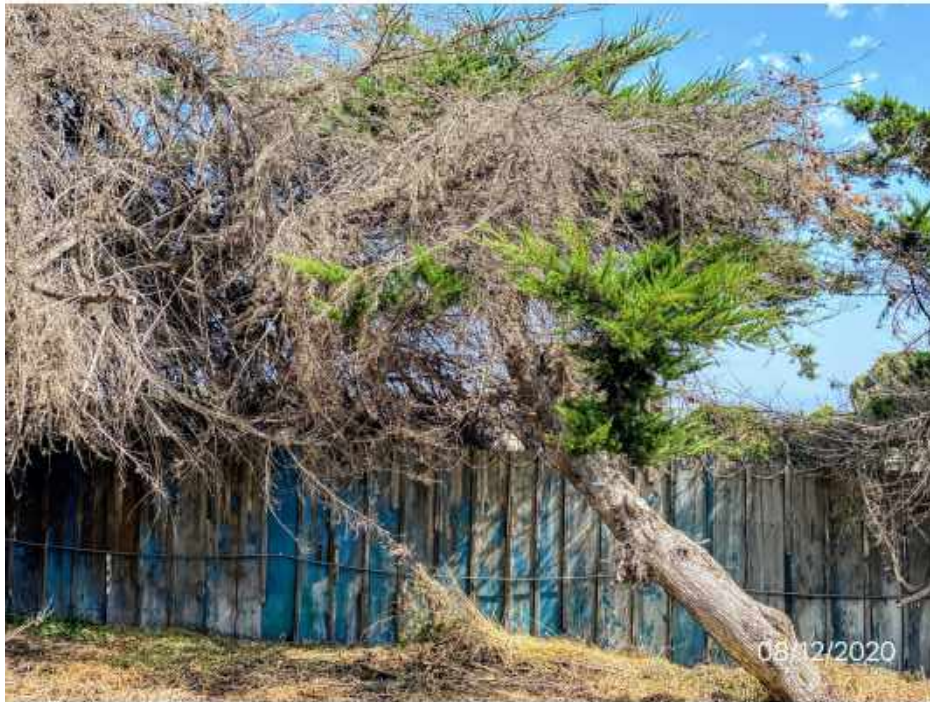
Appendix C – Photographs of Cypress Root Failure

Several cypresses have failed and are leaning over the fenced property line or laying on the ground.

The remaining cypress are in poor health and pose a high risk of trunk or root failure due to extensive decay. Based on DMMC 23.50.080, C.1.), all 14 remaining trees satisfy criteria #1 for removal of dead or dying trees beyond rehabilitation established for a Tree Removal Permit. A total of 19 replacement trees may be required to mitigate the loss of the 14 protected Cypress trees.

The declining health condition of the remaining 14 Monterrey Cypress continues. All the remaining 14 trees were in very poor health condition. Trees #23, #26, #30, and #39 were actively failing toward the northern property line and should be removed.

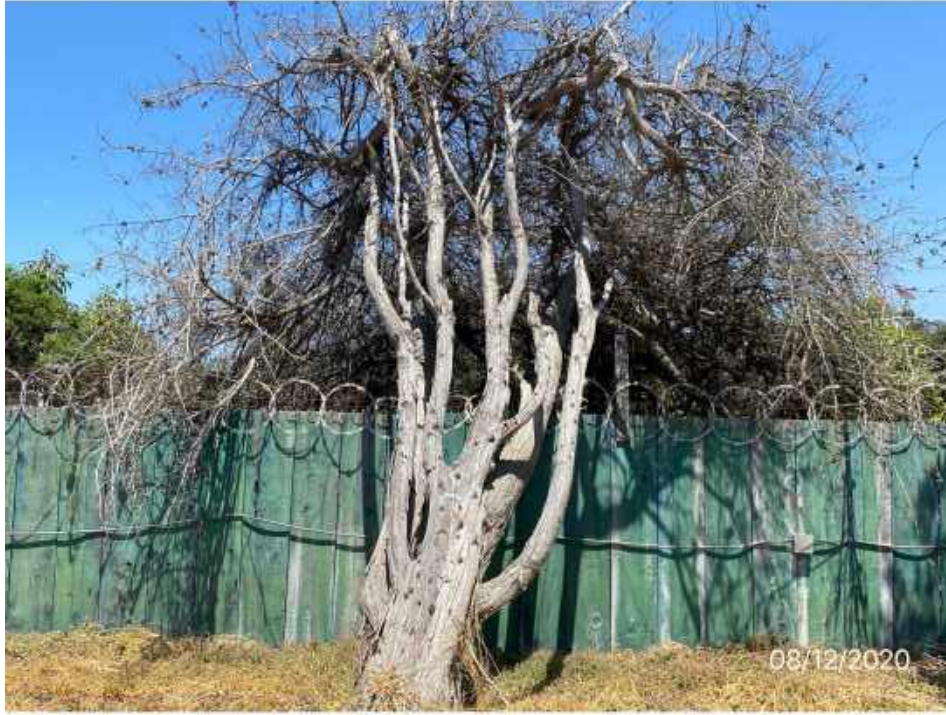
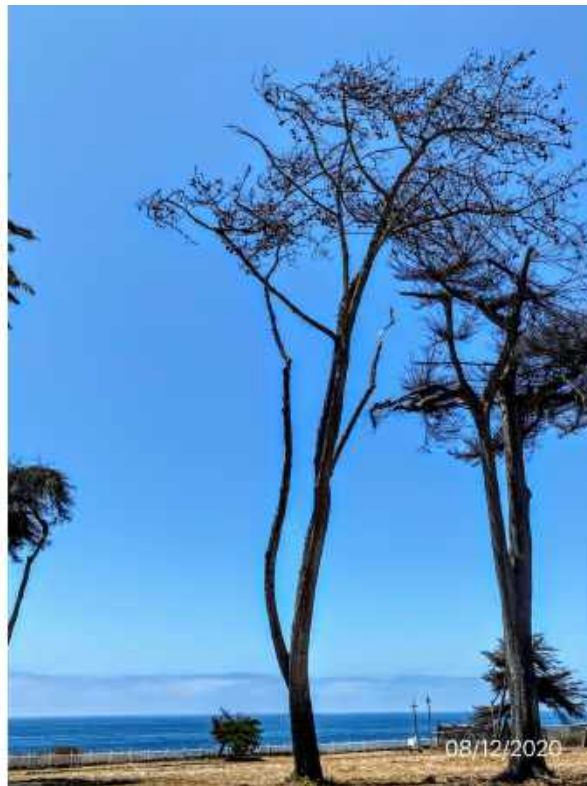
Appendix D - Photographs of Dead Cypress and Torrey Pine

With the exception of one dead Torrey pine, the Monterey cypress comprise all of the protected trees. In general, the cypress are 60-90 years, most are dead, the remainder are in poor health condition. Trees along the norther property line were topped decades ago to form a cypress hedge. Due to trunk and stem decay, several cypress trees have suffered root failure, resulting in trees leaning across the fenced property line or laying on the ground. (See Appendix C – Photographs of Cypress Root Failure). I observed decaying trunks, limbs and in the remaining declining trees. (See Appendix D Photographs of Dead Cypress and Torrey Pine).

In summary, 30 of the 44 Cypress are dead, the remaining 14, although alive, are in severe decline and cannot be rehabilitated. One Torrey pine is dead.
